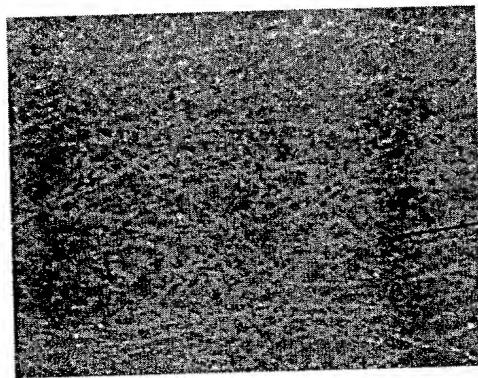
**Fig. 4** The covered stent's surface shows micropores (~15-25  $\mu\text{m}$ ) in the polymer stretched between the covered struts of the metallic stent.

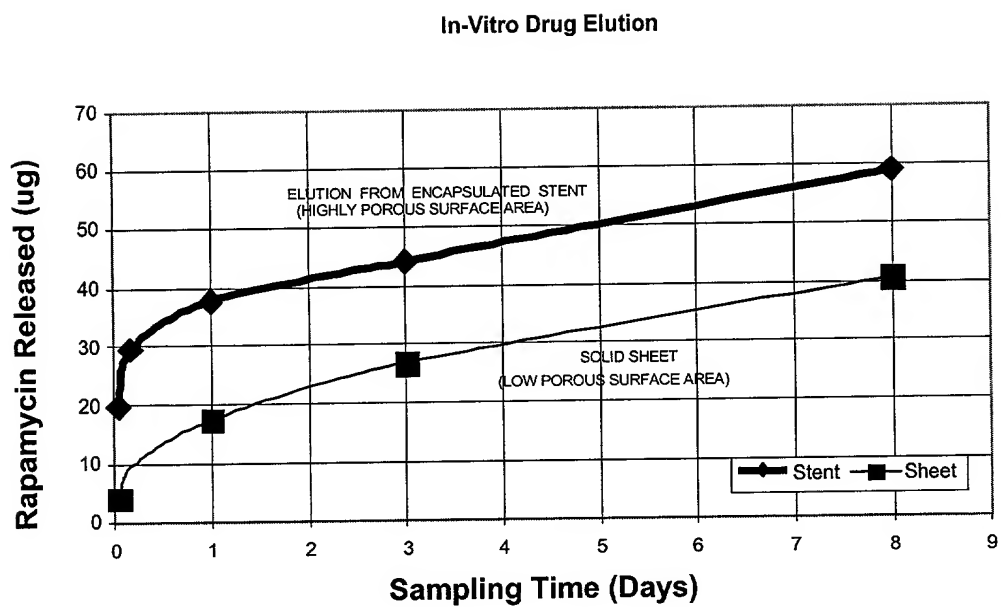
**Fig. 6** In-Vitro Elution Characteristics of Rapamycin in Serum, measured by HPLC .
